U.S. CHEMICAL SAFETY AND HAZARD INVESTIGATION BOARD

INVESTIGATION REPORT

DUST EXPLOSION

**WEST PHARMACEUTICAL
SERVICES, INC.**

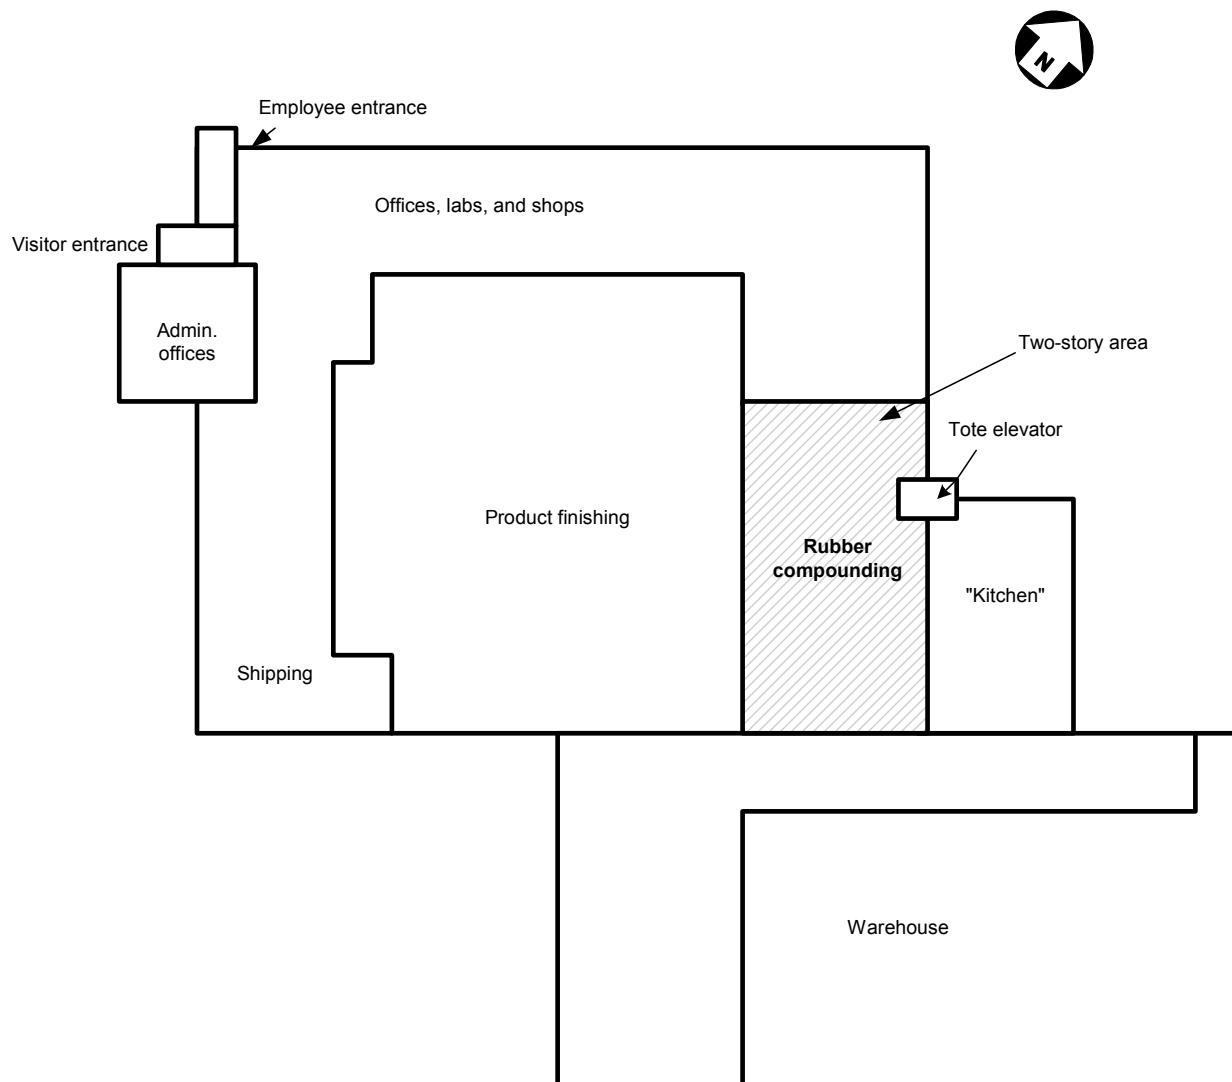
Figure 1. Layout of West Pharmaceutical Services Kinston facility.

Fires developed throughout the facility. The explosion broke feeder lines to the fire sprinkler system, disabling it. The largest and most persistent fire—which burned for 2 days—developed in the warehouse (Figure 1) and involved the large volume of stored baled and strip rubber. Some of the rubber continued to smolder and flare up for about a week.

Rubber and other raw materials were stored in a warehouse southeast of the kitchen and compounding area (Figure 1). The thermal effect from the explosion likely reached this area, igniting incipient fires. Eventually, the entire warehouse was fully engulfed in flames. Heat from the fire caused most of the steel framing to yield and collapse.

West stored mineral oil—a Class IIIB combustible liquid—in two 7,000-gallon plastic tanks and two 300-gallon plastic tanks located inside the building, near the warehouse (Figure 1). The tanks were surrounded by dikes constructed of concrete masonry units. However, because the tanks were installed before North Carolina adopted IFC, there was no legal requirement for West to seek approval of the local authority.

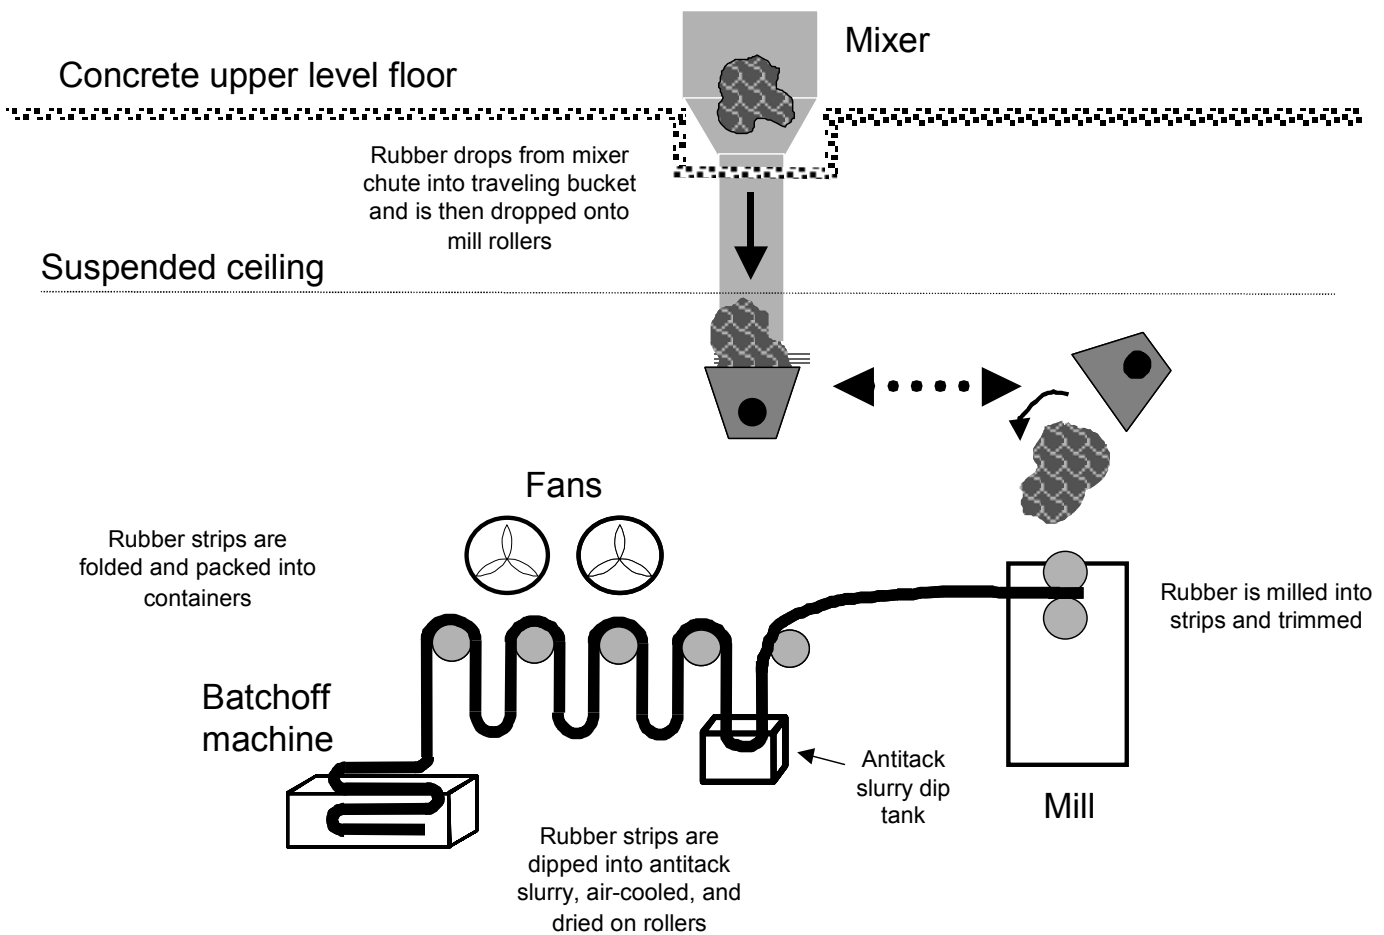
Figure 2. Simplified two-story rubber compounding process diagram.

A suspended acoustic tile ceiling hung 10.5 feet above floor level. The ceiling covered the entire room where the rubber was rolled, dipped, cooled, and folded (Figure 2).
